COMPARISON OF LOAD TEST RESULTS BETWEEN ACIP PILES INSTALLED IN SAND IN PRE-DRILLED HOLES VERSUS CONVENTIONAL INSTALLATION

Tracy Brettmann, A. H. Beck Foundation Company, Houston, TX; Jason Leary, A. H. Beck Foundation Company, Houston, TX; Shailendra Endley, PSI, Houston, TX; Shashank Valluru, PSI, Houston, TX

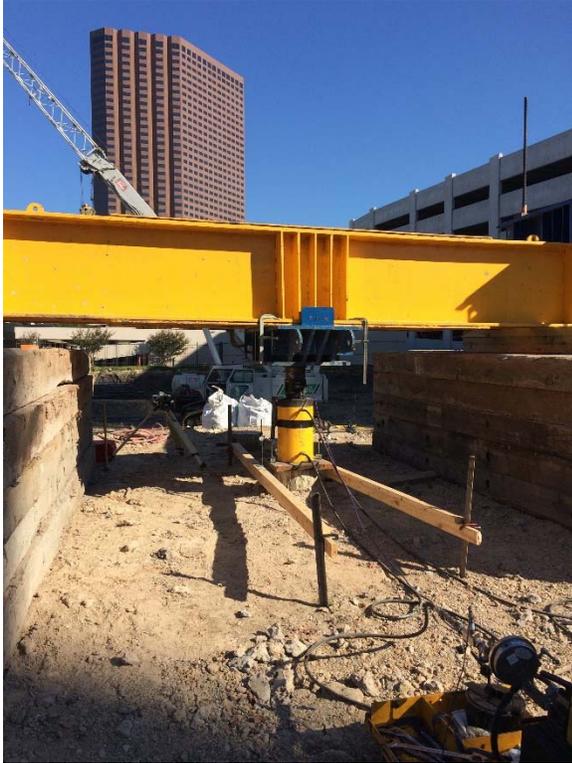
Identical pile load tests were performed on the two test piles in accordance with ASTM D 1143 standards using Procedure A. The piles were loaded to 770 kips in 35 kip increments with 5 minute hold times. After the maximum test load was applied, the piles were unloaded in five equal decrements. The load test on TP-2 is shown in Figure 2.

Figure 2. Load Test on TP-2

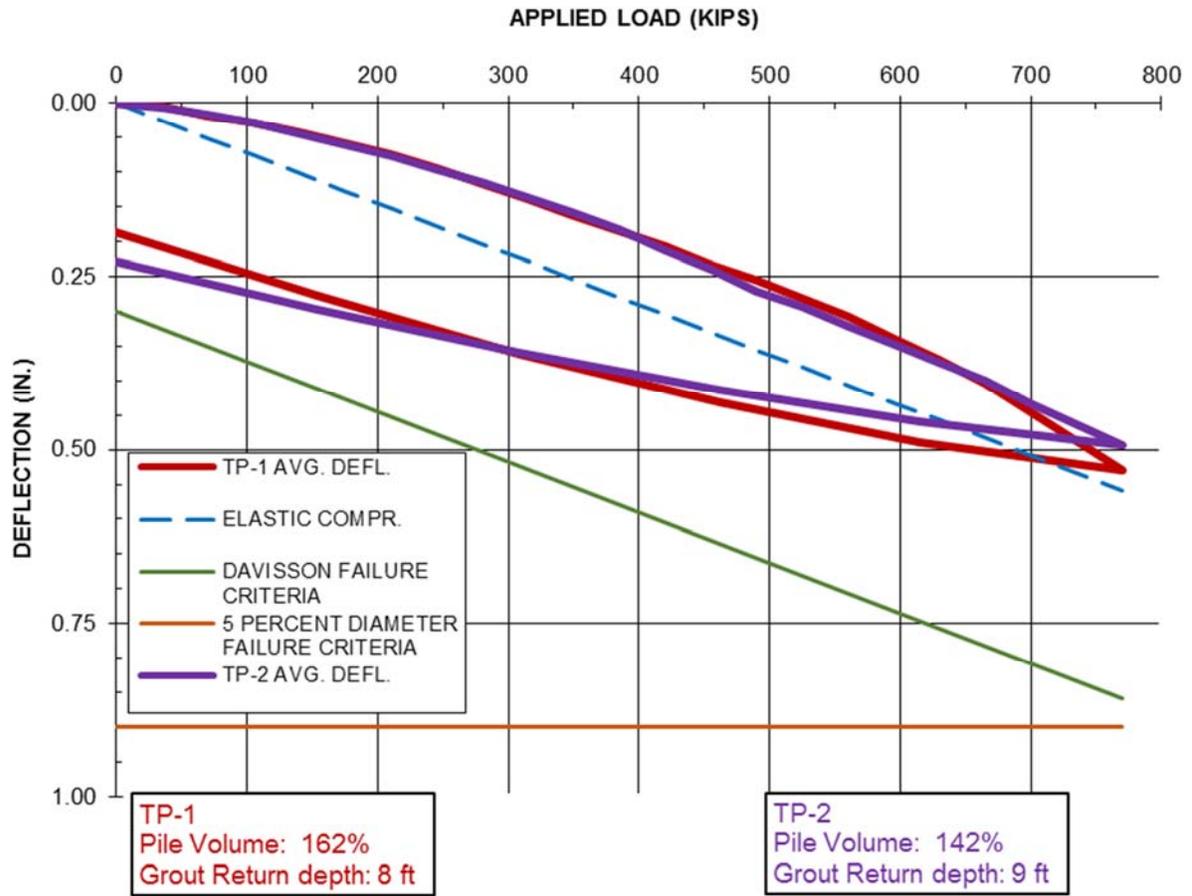
The results of the load tests for TP-1 and TP-2 are shown in Figure 3. Also plotted in Figure 3 is the elastic deformation (PL/AE) of the pile, the Davisson offset failure criteria and the 5 percent of pile diameter failure criteria for reference.

The load tests produced virtually identical load-deflection results indicating there was no effect on capacity due to re-drilling TP-1 in an un-grouted hole. TP-1 did have 20 percent more grout volume pumped in it producing the same grout return depth as TP-2. Thus, TP-1 was a larger diameter pile than TP-2, which

compensated for the loosening of the sands when the auger was withdrawn.

Figure 3. Load Test Results: TP-1 and TP-2

Per IBC code the maximum allowable stress (0.3 f_c) on the pile section results in a load of 385 kips using 5,000 psi grout. Even though the piles didn't reach a deflection based failure criteria at twice design (770 kips), the allowable pile capacity was nonetheless limited to the 385 kip load. Thus, there was no difference in the design capacity of the two test piles.

Identical pile load tests were performed on two test piles that produced virtually identical load-deflection results, indicating there was no overall effect on capacity due to re-drilling one of the test piles in an un-grouted hole.

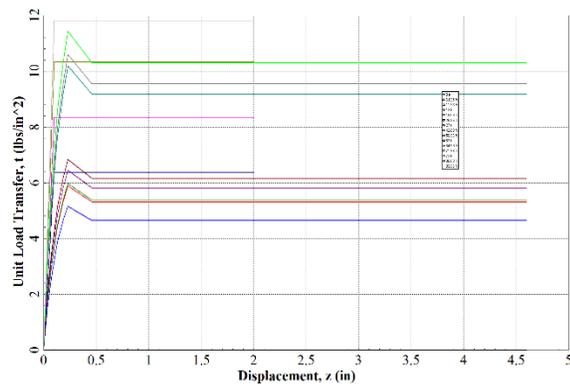
API Recommended Practice 2A (RP2A) load transfer curves were used for both the clay and sand layers in the analyses. The load transfer curves used for both piles are illustrated in figures 4 and 5 for TP-1 and TP-2, respectively. The soil profile used in the analyses was based on boring B-2 conditions discussed previously. This results in a profile that is 53 percent sand and 47 percent clay.

Figure 4. Load Transfer Curves for TP-1

The effective pile diameter used in the analyses was based on the actual measured grout volume pumped in each pile. Therefore, the diameter used for the pile model was 23.0 inches for TP-1 and 21.5 inches for TP-2.

In order to get the computed top deflections to match the measured data, the skin friction values in the sand layers for the TP-1 analyses were reduced in an iterative process. The iterations were completed when the measured and computed deflections converged to the values shown in Table 1. For the final analysis the angle of internal friction of the sand (Φ) was reduced by 5 degrees and the limiting skin friction values (f_{s-max}) was decreased by 20 percent. No material property changes were made to the clay portions of the soil profile.

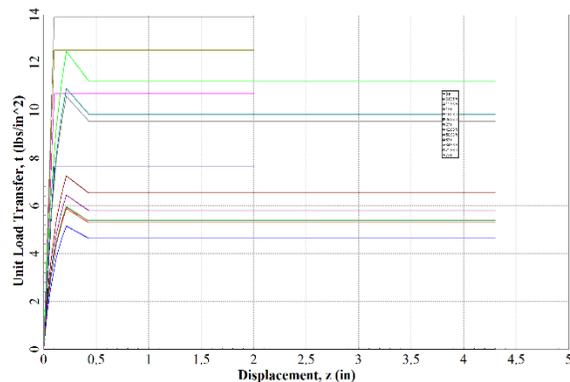
Figure 5. Load Transfer Curves for TP-2
