A Low Headroom Solution

An emergency bridge repair project told from the specialty geotechnical contractor's point of view as it unfolded.

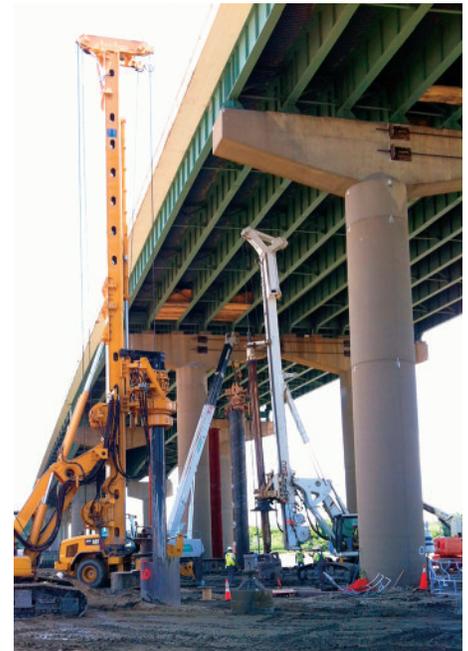
Drill rigs working at bridge site

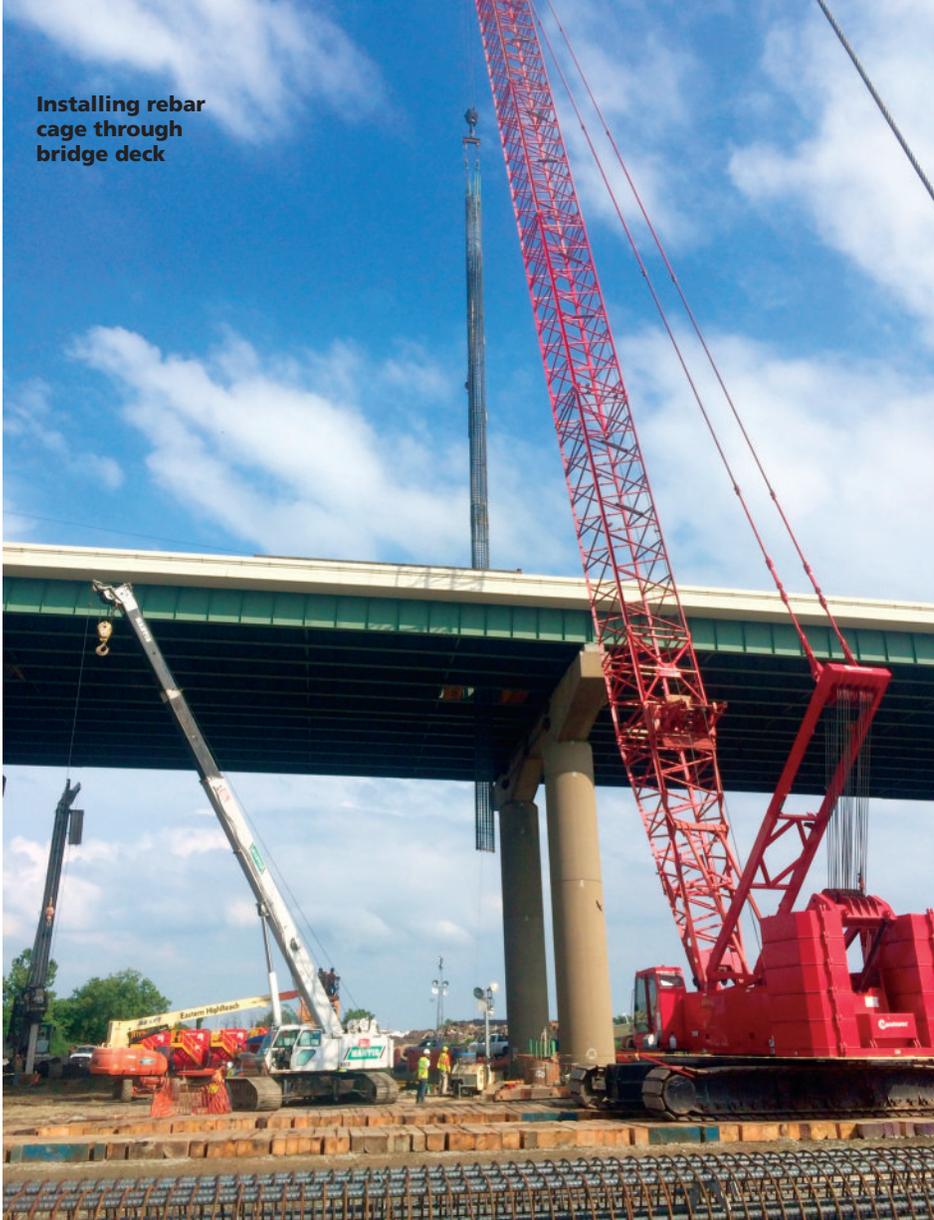
Installing rebar cage through bridge deck

of the project. A 250 ton (227 tonne) capacity crawler crane with 300 ft (90 m) of boom was required to pick the 30,000 lb (130 kN) rebar cage above the bridge deck. The rebar cages were all set full length in a single piece with no splices through a temporary opening in the bridge deck cut exactly above each shaft.

Another major issue was how to install the rebar cages. The initial plan was to splice the cages together in sections over the open hole. This was problematic due to both the time it would take and the constructability of having to couple many bars together over an open hole. During a meeting onsite with the project team we suggested that the cages could be installed in one piece, however it would require cutting a temporary hole in the bridge deck and positioning the shafts between the bridge beams. While this was initially considered a somewhat radical idea, as the project team discussed it in more detail it became apparent that there was actually no reason why we couldn't do it. The task would require that same collaborative effort between the designers and contractors that was used for the casing installation portion

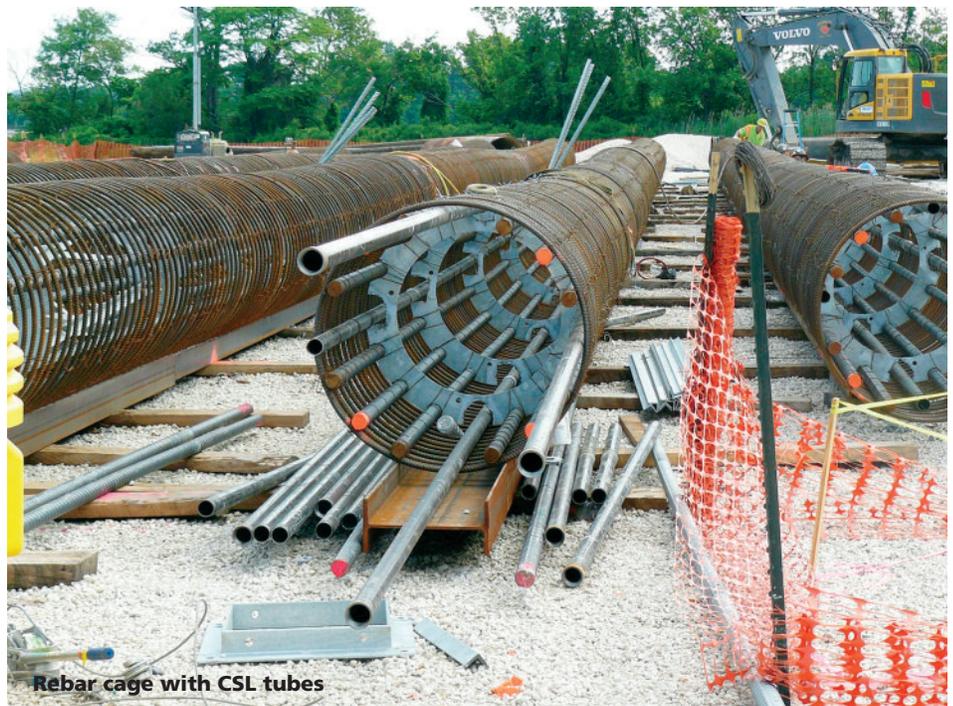
Rebar cage with CSL tubes

This project included the first use of self-consolidating concrete (SCC) in drilled shafts for DelDOT. Because the shafts were advanced with slurry, a special mix design was required to allow the concrete to effectively flow through the rebar and eliminate the potential for defects. All of the shafts were installed with crosshole sonic logging (CSL) tubes for integrity testing after completion. Based on our experience with both SCC and CSL on large slurry drilled shafts the project team agreed to use a special mix design.
